MedSun Newsletter #58, March 2011

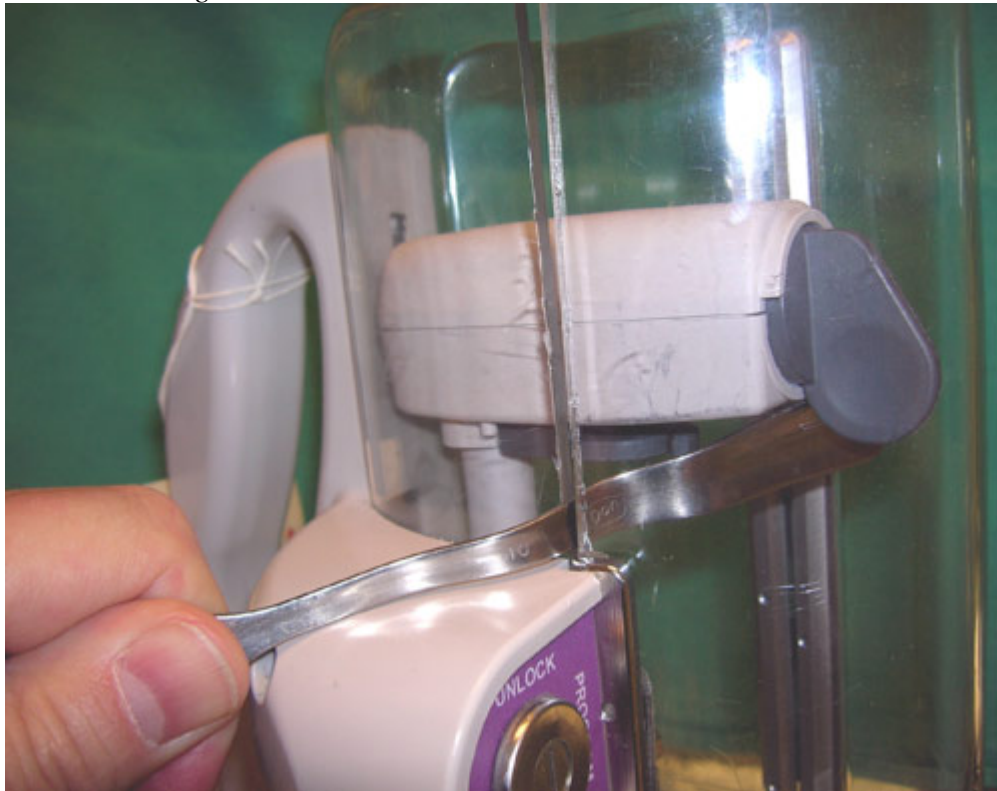
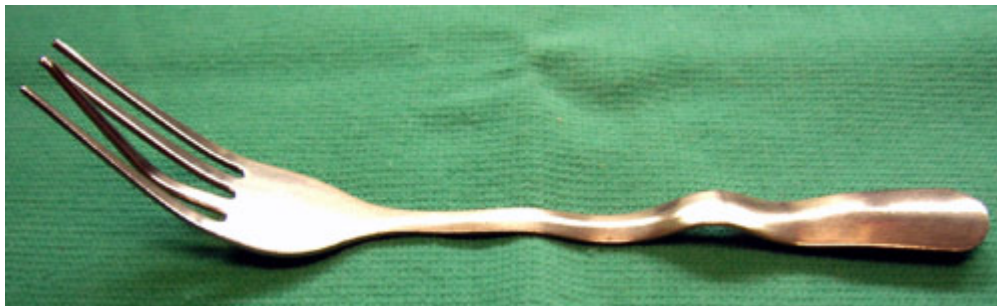
See device images:

A patient bent a metal fork into a specific shape that allowed him to disengage the plunger mechanism on an Alaris 8120 PCA Module. Once the plunger head was raised above the syringe the patient pressed down on the syringe plunger and self-administered 13mg of Dilaudid. Patient was found unconscious and in respiratory arrest with an O2 sat level of 40%. A reversing agent was administered. After the patient recovered he admitted what he had done, produced the fork and demonstrated how he was able to manipulate the PCA Module. A Clinical Engineering technician was able to duplicate the event. The PCA Module and the fork have been sequestered for further investigation.

The design of the syringe cover allows the introduction of very thin objects into the compartment containing the PCA syringe. There is a very small crack between the two cover halves (1 to 2 mm) when the cover is locked. A tool can be used to turn the release knob and disengage the plunger head if the tool is bent in a very specific pattern.
